A Product of the  
NASA SAFETY CENTER &  
OFFICE OF THE CHIEF KNOWLEDGE OFFICER, GODDARD SPACE FLIGHT CENTER

# Selected NASA CASE STUDIES

February 2009

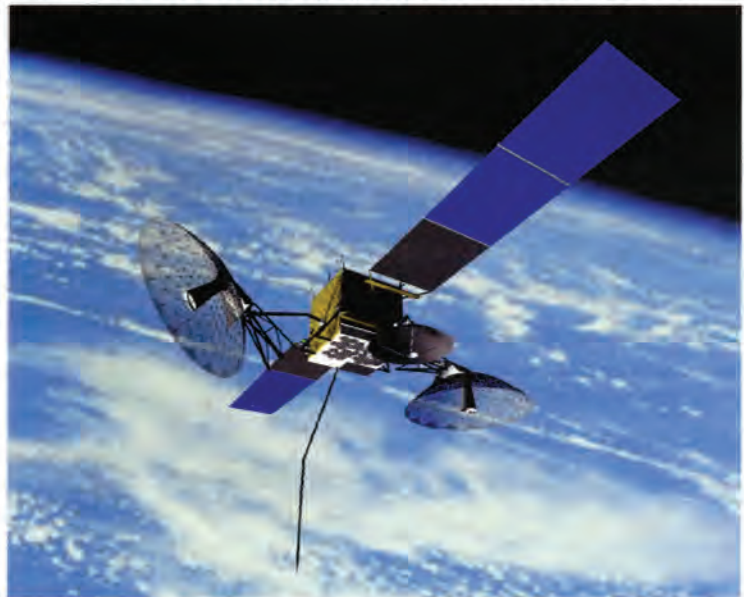
*Artist's conception of basic TDRS design for H through L. NASA image*

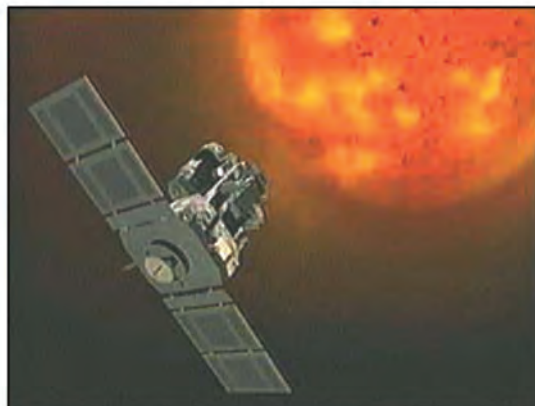
**Figure 1:** Artist's conception of the SOHO spacecraft.

SOHO also contained a second gyro (Gyro B), used solely for fault detection (e.g. to sense roll rates beyond some predetermined tolerance). If an excessive roll rate was detected, SOHO was triggered to enter a "safe mode," where it ensured that its panels were facing the Sun, temporarily suspended the ACU computer, and then awaited ground commands. This was called an Emergency Sun Reacquisition (ESR) mode, and it required ground commands to restore normal operations under the ACU. During recovery from an ESR, ground controllers used the third and final gyro (Gyro A), instead of Gyro C, for roll rate sensing. The recovery sequence finished with a recalibration of all three gyros and a restoration of Gyro C to roll rate sensing.
